# Manhole Inspection Summary

Manhole # S09MM1016MH

Insp Date: **1/20/09 4:35 PM**

**Location** Address: **3530 MANCHESTER AVE**

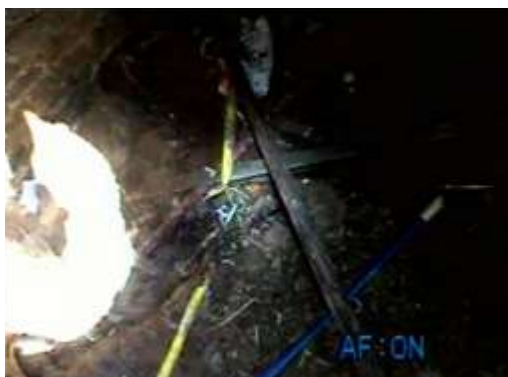
Defect 1

Condition: ☐ Sound ☐ Cracked ☐ Root Intrusion ☐ Deteriorated ☐ Leaks ☒ **Debris**

**Surcharge** ☒ **Evidence Of Surcharge** Depth: **2** (ft.) ☐ Active Surcharge Present

EVIDENCE OF ASUR

NOTE- DEBRIS ON BENCH AND IN CHANNEL, AND SURCHARGE ON RUNG

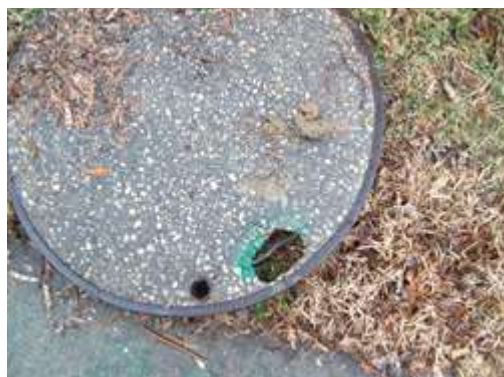
Defect 2

Type: **Sanitary** Condition: **Broken** Cover Material: **Cast Iron**

BROKEN LID

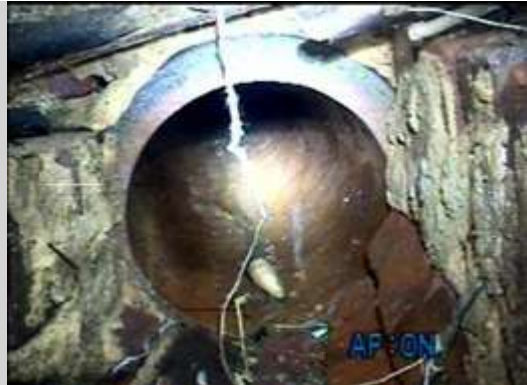
12 O'Clock Outflow

8 in. Circular Gravity Sewer  
Pipe Out @ 12 O'Clock

Infiltration: **None** Pipe Seal Cond: **Sound**

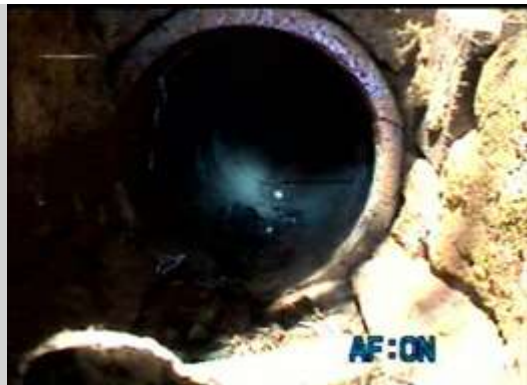
3 O'Clock Inflow

6 in. Circular Gravity Sewer  
Pipe In @ 3 O'Clock

Infiltration: **None** Pipe Seal Cond: **Cracked**
